Manhole Inspection Summary

Manhole # S45E__043MH

Insp Date: **8/14/08 9:45 AM**

Location Address: **LOBARD**

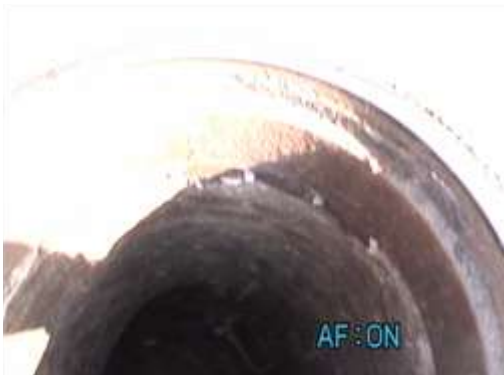
Defect 1

Offset: **0.5** (in.)

☒ **Leaks**

Frame leaks

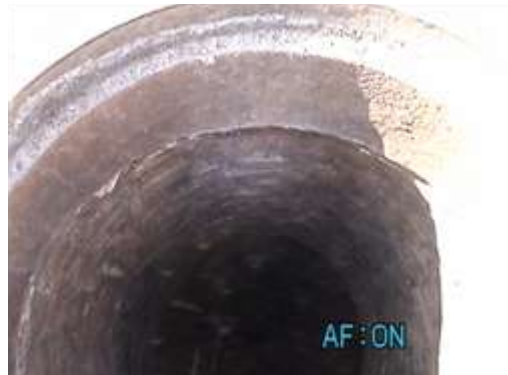
Defect 2

Infiltration: ☐ None ☐ Joint ☐ Cracks ☒ **Mortar** ☐ Roots ☐ Wall

Infiltration: ☐ None ☐ Joint ☐ Cracks ☐ Mortar ☐ Roots ☒ **Wall**

Infiltration

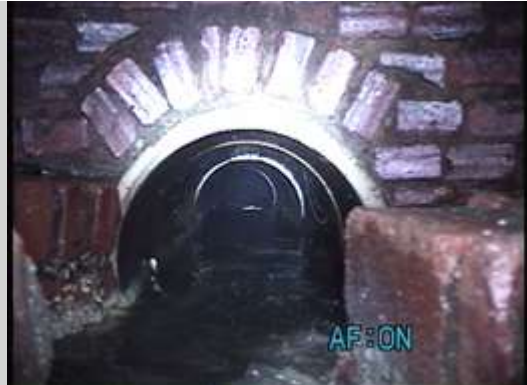
12 O'Clock Outflow

Pipe Height: **15.6** (in.) Rod and Bar (Angled)
Pipe Material: **Clay** ☐ Pipe Lined
Invert Depth: **21.00** (ft.) Flow Characteristics: **Fast**
Deposits: ☒ None ☐ Mud ☐ Sludge ☐ Debris ☐ Grease
Silt Depth: (in.) Deposits Extent:
Infiltration: **None** Pipe Seal Cond: **Sound**

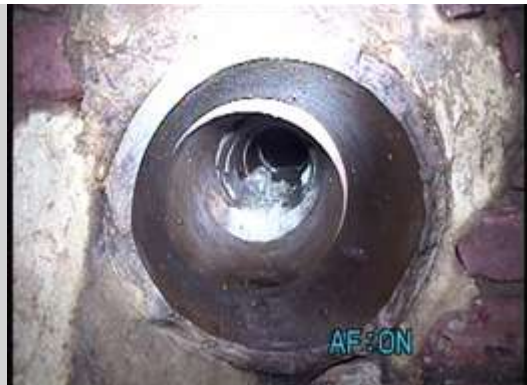
3 O'Clock Inflow

Pipe Height: **8.4** (in.) Rod and Bar (Angled)
Pipe Material: **Clay** ☐ Pipe Lined
Invert Depth: **12.20** (ft.) Flow Characteristics: **Fast**
Deposits: ☒ None ☐ Mud ☐ Sludge ☐ Debris ☐ Grease
Silt Depth: (in.) Deposits Extent:
Infiltration: **None** Pipe Seal Cond: **Sound**

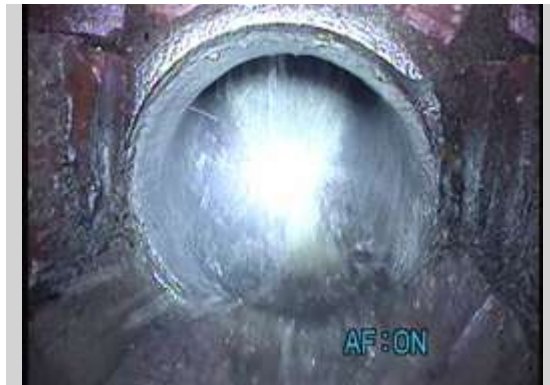
Drop In @ 3 O'Clock

Drop: **Inside** Rod and Bar
Angled: **Yes** Reading: **19.40** (ft.)
Inv Depth: **20.40** (ft.)
Drop Condition: **Open**

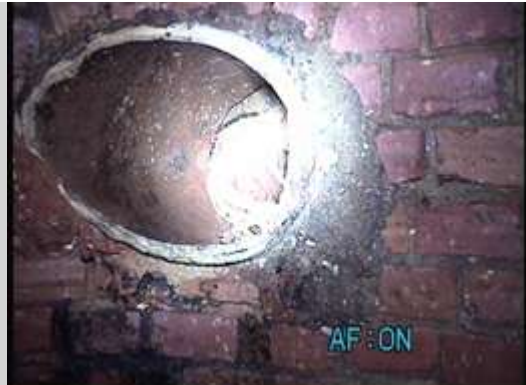
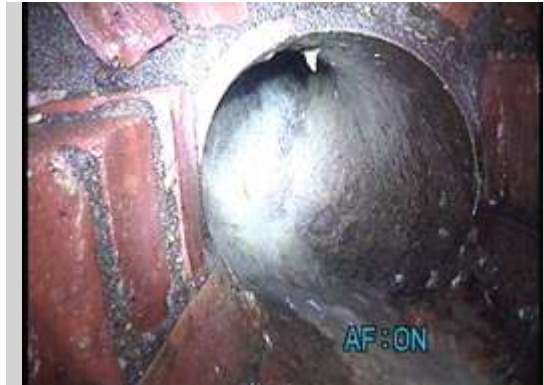
6 O'Clock Inflow

Pipe Height: **8.4** (in.) Rod and Bar (Angled)

Infiltration: **None** Pipe Seal Cond: **Sound**

Drop: Inside	Rod and Bar
Angled: Yes	Reading: 19.20 (ft.)
	Inv Depth: 20.20 (ft.)
Drop Condition: Open

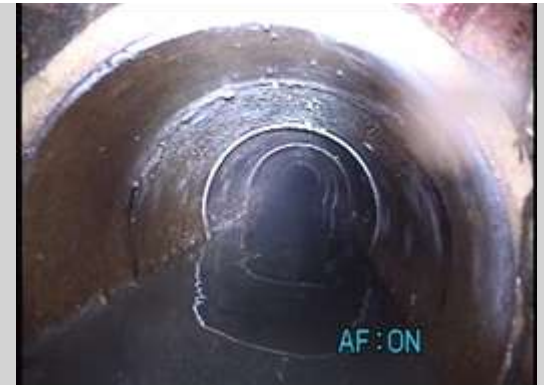
9 O'Clock Inflow

Pipe Height: **15.6** (in.) Rod and Bar (Angled)

Infiltration: **None** Pipe Seal Cond: **Sound**
